Valve adjustment on my M66

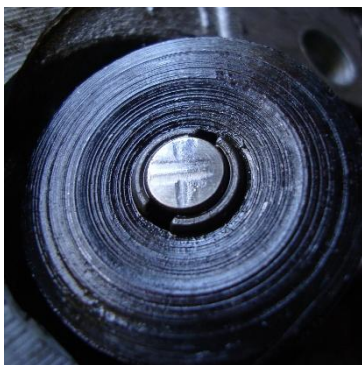
The rocker mark shown here which doesn't go right across the valve is from Serenity (my M66) "as found". Then, the rocker missed the valve to some degree and needed shimming up or down to prevent it from pushing the valve sideways. Note also what seems to be two rocker marks, made at different times by rocker geometry which didn't push the middle of the valve stem. This also stressed the valve guide by pushing the valve sideways as well as down. From the factory, any rocker geometry will do. It's a Ural, it's cheap, what were you expecting? But notice the other mark, which *does* reach all the way across the valve. This is after the rocker's been shimmed up and the geometry fiddled to push the valve down straight, to give the guide an easier life. The geometry depends on the mathematical relationship between the

rocker spindle centres and the valve stem length. Any rocker assembly paired with any valve, the depth it rests on the seat, and the angle the guide holds it at all make a difference to the rocker geometry. If you've nothing better to do, you can become deeply involved in the minutiae of correcting rocker geometry by grinding the valve deeper, grinding the end off the stem if it's too deep already or shimming the base of the rocker pedestal in search of the perfect rocker mark. Is it worth it? It's your motorcycle, you tell me, but if your valve guides wear out quickly, this is why.
